Source: Prestolite Electric Ltd - Greenford, London, UK
Date: July 31, 2008
Bulletin No: TSB4028
Models: AC203R, AC203RA Alternators
Subject: Vehicle fitment support

Vehicle fitment support for AC203R & AC203RA alternators

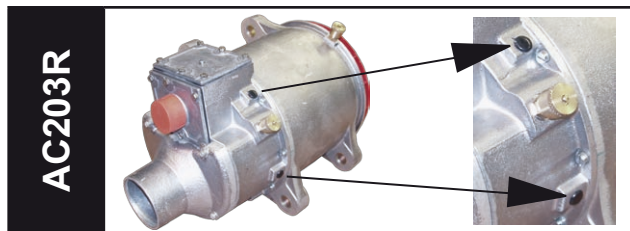
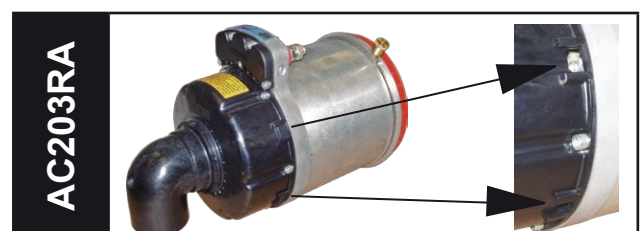
Drain plug removal

The AC203R and AC203RA range of alternators are fitted with drain plugs in the rear housing assembly. There are 6 drain holes spaced around periphery of the rear housing.

Failure to remove drain plugs will cause build-up of moisture in rear housing and cause aggressive corrosion of rectifier assembly and rapid alternator failure.

Once the alternator is fitted to the vehicle the lowest plug(s) MUST be removed, to allow for drainage of moisture.
