# Technical Service Bulletin

Source: Leece-Neville Heavy Duty Systems Division -  
Arcade, NY USA  
Date: July 7, 2017  
Subject: Restoring Alternator Residual Magnetism  
Bulletin No: TSB-1034  
Models: A001 series, 8LHA type families, 5000 and 7000 Series

## Procedure for restoring alternator residual magnetism (Full Fielding).

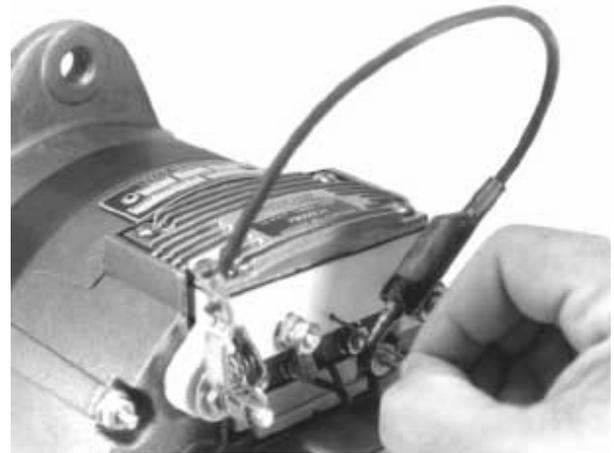
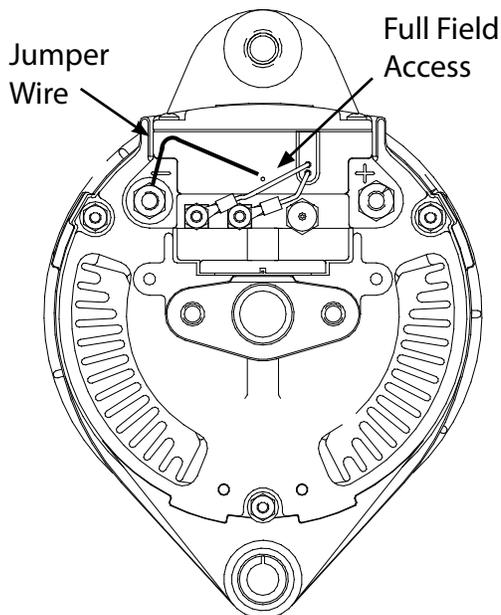
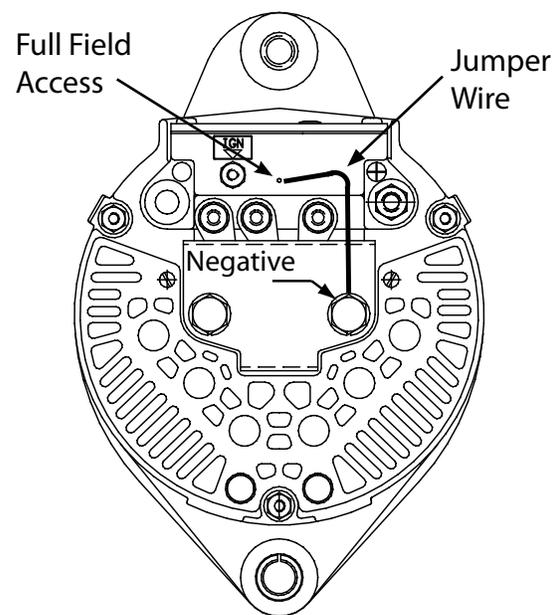
Figure 1

### 2500, 2800, 4800, 4900, 8000, 9000 alternator family (Figure 1)

1. Make sure voltage is present at alternator output terminals
2. With the engine off, connect a short jumper to the alternator NEGATIVE output terminal and to a piece of stiff wire or 1/16" drill. Insert the drill in the "full field access hole" as far as it will go for 1-2 seconds. This will restore the residual magnetism in the rotor (Figure 1).
3. Remove stiff wire or 1/16 drill and jumper wire.

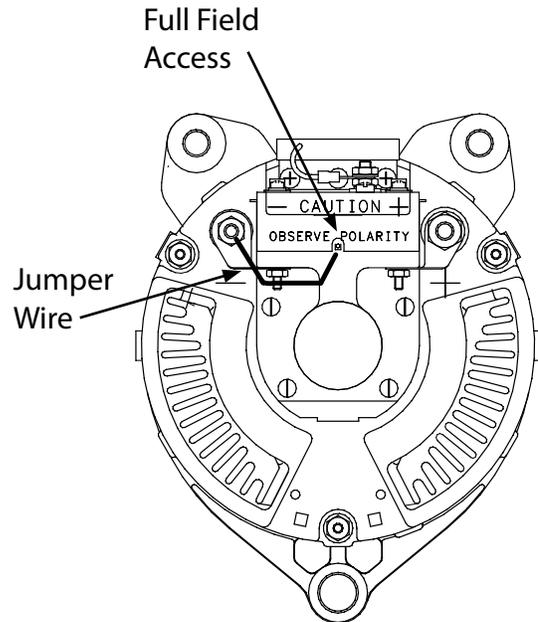
Figure 2

## 5000, 7000 alternator family (Figure 2)

**NOTE: DO NOT!!! attempt to flash the alternator's field when the engine is running. Serious damage can be done to the vehicle's electrical system.**

1. Make sure voltage is present at alternator output terminals.
2. With engine off, connect a short jumper to the alternator NEGATIVE output terminal and to a piece of stiff wire or 1/16" drill. Insert the drill in the "full field access hole" as far as it will go for 1-2 seconds. This will restore the residual magnetism in the rotor (Figure 2).
3. Remove stiff wire or 1/16" drill and jumper wire.

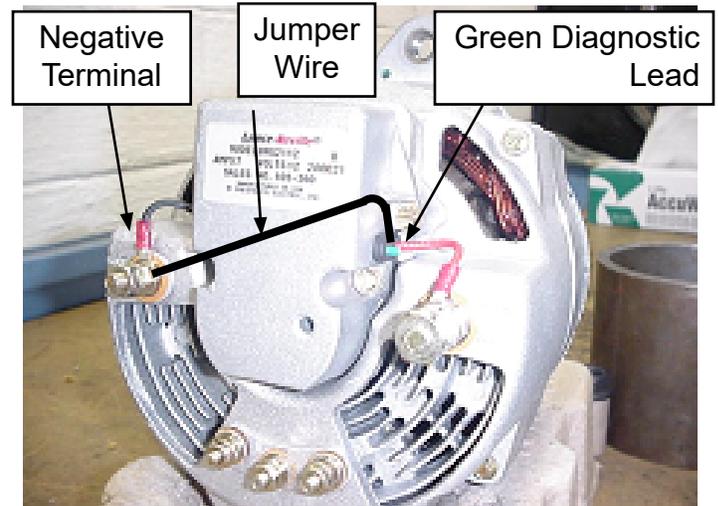
Figure 3

## 8LHA, 8LHP, LBA, LBP, BLD, BLP alternator family (Figure 3)

**Note: It may be necessary to attach A paper clip to the end of the jumper wire in order to make contact to the green diagnostic lead**

1. Make sure voltage is present at alternator output terminals.
2. With engine off, connect a short jumper to the alternator NEGATIVE output terminal and green diagnostic lead for 1-2 seconds. (Diagnostic lead located by positive output terminal.)
3. Remove jumper wire.
