Source: Prestolite Leece-Neville Heavy Duty Systems
Bulletin No: TSB-1228 **Date:** August 08, 2023
Models: BLD / BLP4000
Subject: Terminal identification when replacing Remy 40Si

This document is to identify terminals between Prestolite BLD / BLP4000 to Remy 40Si alternators.

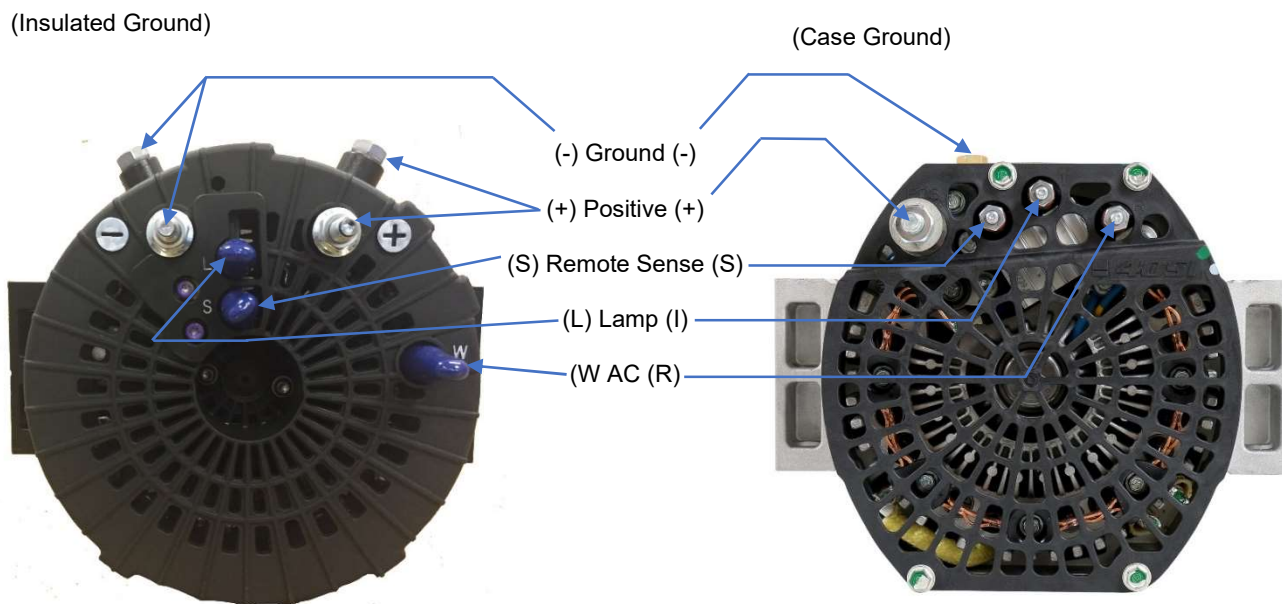
Note: Two positive and negative connections on BLD / BLP4000 series alternators are common connections.
Use the connection that works best in your application.
